Manhole Inspection Summary

Manhole # S290__044MH

Location Address: **901 W HAMBURG ST**

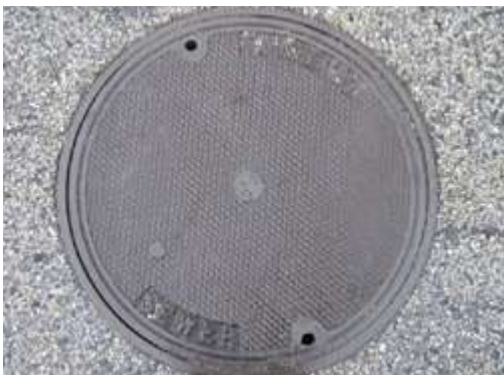
Cover Pic

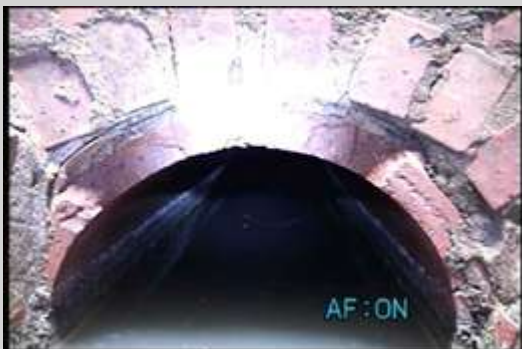
6 O'Clock Inflow

15 in. Circular Gravity Sewer
Pipe In @ 6 O'Clock

Pipe Height: **15.6** (in.) Rod and Bar (Angled)
Pipe Material: **Clay** ☐ Pipe Lined
Invert Depth: **9.16** (ft.) Flow Characteristics: **Slow**
Deposits: ☒ **None** ☐ Mud ☐ Sludge ☐ Debris ☐ Grease
Silt Depth: **0** (in.) Deposits Extent:
Infiltration: **None** Pipe Seal Cond: **Sound**

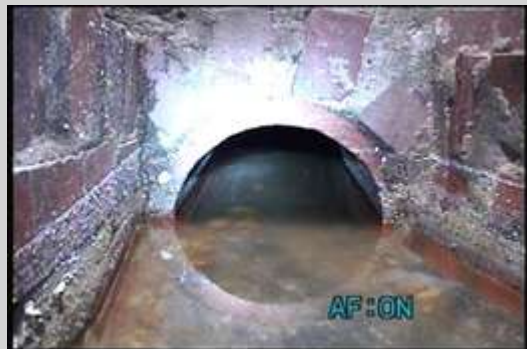
9 O'Clock Inflow

8 in. Circular Gravity Sewer

Pipe In @ 9 O'Clock

Pipe Height: **8.4** (in.) Rod and Bar (Angled)

Infiltration: **None** Pipe Seal Cond: **Sound**
